Appendix J1

Geologic Assessment

**GEOLOGICAL ASSESSMENT FOR
U. S. 281 FROM LOOP 1604 TO BORGFELD ROAD,
BEXAR COUNTY, TEXAS**

6 December 2010

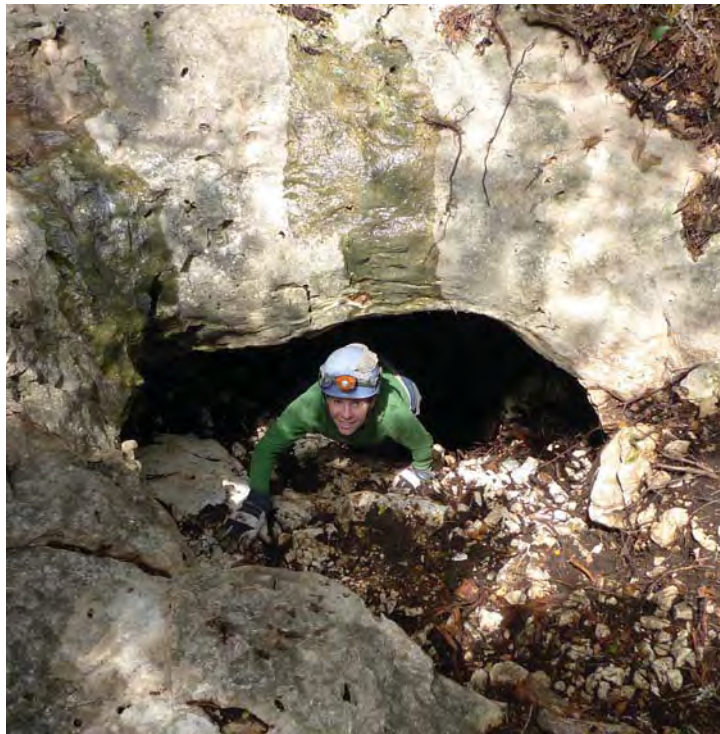
Caption: Surveyor exiting Taco Truck Tunnel (feature 281-025) during excavation.

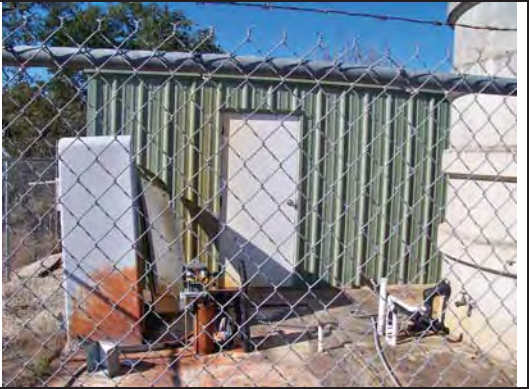
Field ID	Description	Photo
281-001	This feature is a water well with a 0.15 m (0.5 ft) diameter.

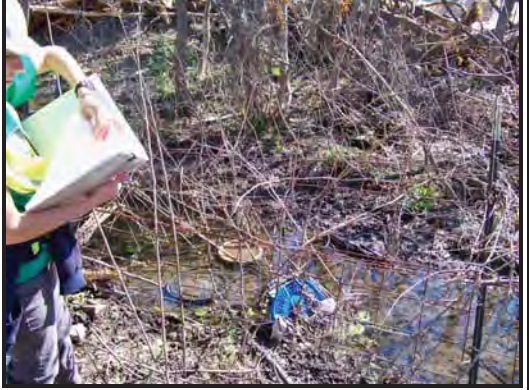
281-002	This is a spring that lies just outside of the eastern US 281 right of way, south of Borgfeld Road. Part of the spring pool is within the ROW, but the apparent spring source is on private land where right of entry was not granted. The spring appears to emerge from sediments, with no obvious single source. The spring pool measured 2 by 7 m (6.6 by 23 ft) when first recorded on 26 February 2010. Surface flow from the spring sank into sediments just downstream of the pool.

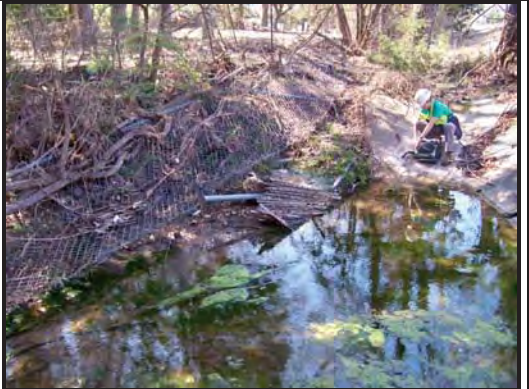
281-003	This spring is located along the eastern US 281 ROW just south of Borgfeld Road. There are five distinct spring sources; four of these emerge from sediment in an area that is 7 m (23 ft) long by 2 m (6.6 ft) wide by 0.3 m (1 ft) deep. The fifth emerges from a weep-hole pipe at the base of a concrete skirt constructed as part of the highway. The source of this water is unknown. The spring pool is bisected by the ROW limit.

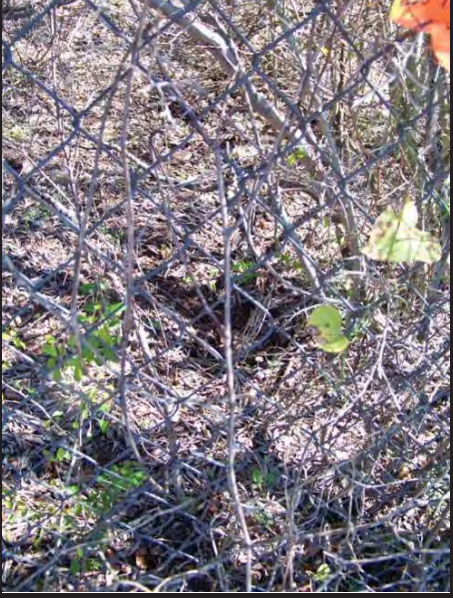
<p>281-004</p>	<p>This is a closed depression that is situated on private property where right of entry was not granted. It is just across a fence line at the base of a persimmon tree. The feature is 0.7 m (2.3 ft) long, 0.5 m (1.6 ft) wide, and 0.25 m (0.8 ft) deep. It may be a solutional sinkhole, or it could be an animal burrow. No right of entry was available for further evaluations.</p>

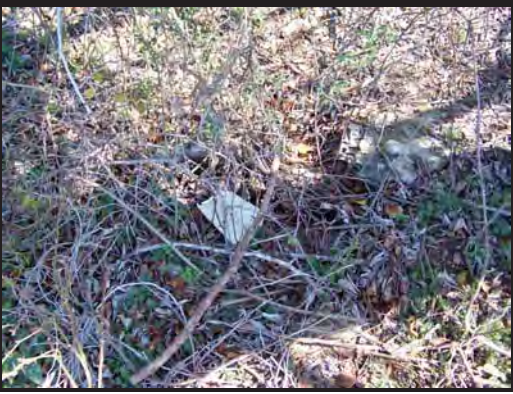
<p>281-006</p>	<p>This solution enlarged fracture is in the road cut on the west side of US 281. The entrance to it is 0.8 m (2.6 ft) wide, 0.4 m (1.3 ft) high, and it extends into the road cut for 1 m (3.3 ft). It contains no infill.</p>

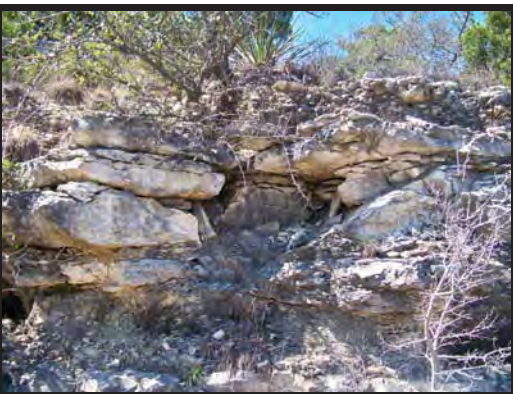
281-007	This solution cavity is situated in the road cut on the west side of US 281. The entrance to the feature is 0.7 m (2.3 ft) wide, 0.5 m (1.6 ft) high, and it extends into the road cut for 0.5 m (1.6 ft). It is an enlarged bedding plane with no infill.

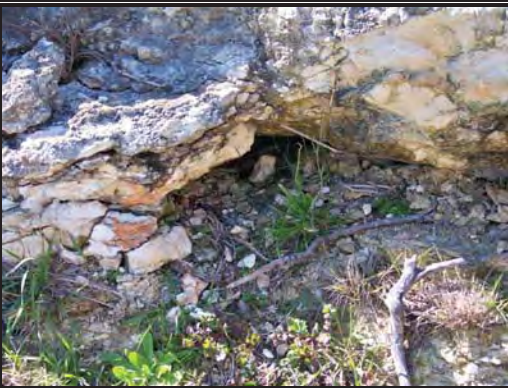
281-009	This is a pair of closed depressions on private property on the west side of US 281. The feature measures 1.5 by 1 m (4.9 ft by 3.8 ft), and is 0.3 m (1 ft) deep. It may be karstic in origin, or it may have an anthropogenic origin related to a nearby natural gas pipeline. Excavation would be needed to make that determination, and was recommended. Right of entry for excavation purposes was not granted.

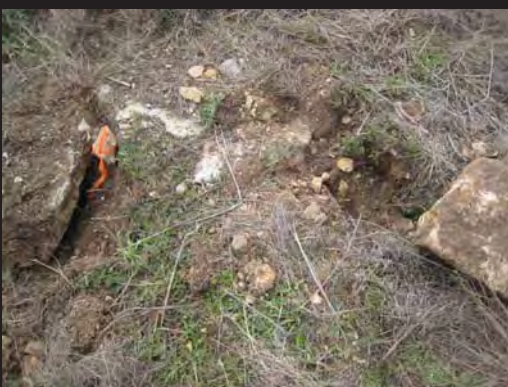
281-010	This is a seep spring located on private property on the west side of US 281. It flows from the travertine covered base of a 3 m (9.8 ft) tall cliff in an area that is 2 m (6.6 ft) long by 1 m (3.3 ft) wide, but it does not have an identifiable portal. A small amount of water was flowing from it when assessed on 1 March 2010.

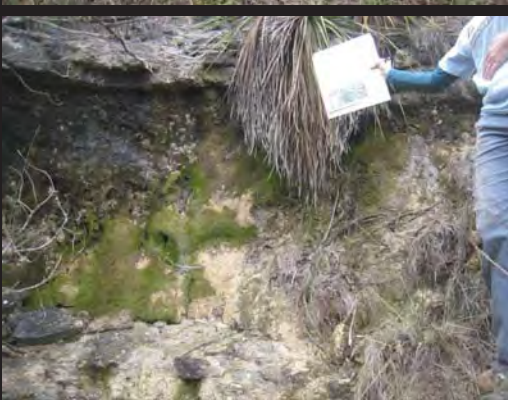
<p>281-011</p>	<p>This non-karst closed depression is located on private property between a house and some storage units. When first located it was 1.5 m in diameter and 0.7 m deep, and filled with loose rocks and snakes. Excavation was recommended to determine its origin. This was conducted on 10 August 2010. During this excavation effort, 9.25 person-hours of effort were expended and 1.25 m³ of material was removed. This resulted in a rectangular depression 2.5 m (8.2 ft) long, 1.5 m (4.9 ft) wide, and 1 m (3.3 ft) deep, with a floor of hard-packed soil. Trash was removed from this excavation, and a rusty metal pipe leads into it. This feature appears to be some kind of old septic facility and is not karst-related.</p>

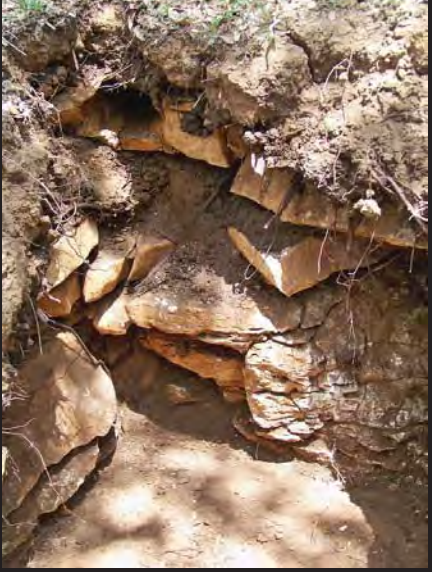
<p>281-012</p>	<p>This is a spring/solution cavity that emerges from two small bedrock openings in the middle of a creek bed that are 0.2 m (0.7 ft) in diameter. When the site was recorded on 1 March 2010, water was flowing from both the spring orifices and from upstream in the creek. It is not known if the water coming from the spring is merely pirated from the stream flow nearby, or if it has a more distant source.</p>

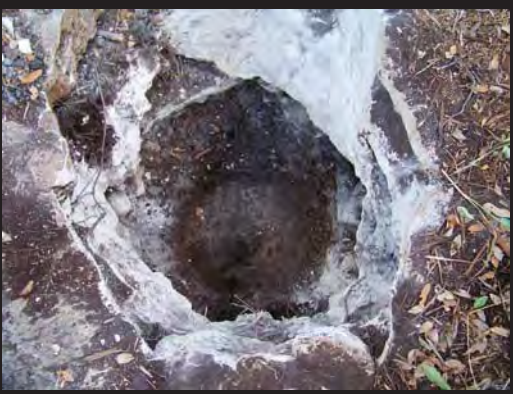
<p>281-014</p>	<p>This is a closed depression that when initially assessed was 1.5 m (4.9 ft) long, 1 m (3.3 ft) wide, and 0.6 m (2 ft) deep. It was filled with leaf litter and modern soils. The troglophile meshweaver spider <i>Cicurina varians</i> was found in this feature. This feature was excavated on 10 August 2010 utilizing 0.8 person-hours of effort, resulting in the removal of 0.1 m³ (3.5 ft³) of material. A bedrock floor was reached at 0.7 m (2.3 ft) depth, with no mesocavernous voids leading off of the feature. The post-excavation dimensions of the feature were 1.5 m (4.9 ft) long, 1 m (3.3 ft) wide, and 0.7 m (2.3 ft) deep.</p>

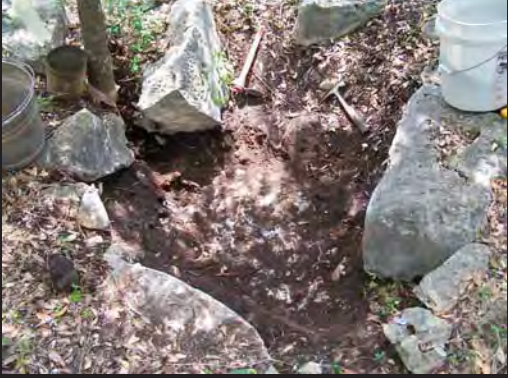
<p>281-015</p>	<p>This sinkhole is a depression is located on private property. It is 1.5 m (4.9 ft) long and 0.7 m (2.3 ft) wide, and was covered with trash when initially located on 2 March 2010. It had soil and leaf litter infill that was loose to a depth of 0.2 m (0.7 ft). The troglophilic meshweaver <i>Cicurina varians</i> was found in this feature. Excavation for further evaluation of karst invertebrate habitat was conducted on 10 August 2010 for one person-hour, resulting in the removal of 0.1 m³ (3.5 ft³) of material. A floor of hard-packed clay was reached at 0.25 m (0.8 ft) depth, with no mesocavernous voids extending from the feature. Post-excavation dimensions of the feature were 1.6 m (5.2 ft) long by 0.8 m (2.6 ft) wide by 0.25 m (0.8 ft) deep.</p>

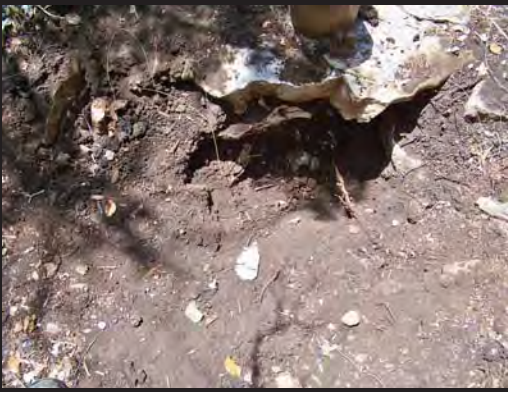
<p>281-016</p>	<p>This enlarged fracture is located in the east road cut of US 281. When initially assessed on 2 March 2010. It had an opening 0.1 m (0.3 ft) in diameter, and it split into two routes with an estimated depth of over 1 m (3.3 ft). Airflow was detected, suggesting a continuation, therefore excavation of the feature was conducted for further evaluation. On 18 June 2010, 5 person hours of excavation effort was expended utilizing an electric chipping hammer. One cubic meter (35 ft³) of material was removed. The feature was enlarged to a width of 1.5 m (4.9 ft), with several large slabs still blocking the way. These were removed with a jackhammer on 21 June 2010 in an effort that involved 6 person hours of labor and the removal of an additional 1 m³ (35 ft³) of material. Post-excavation dimensions of the feature were 0.7 m (2.3 ft) long by 1.5 m (4.9 ft) wide by 1 m (3.3 ft) deep. Bedrock was reached, with no signs of a drain or karst processes. This feature was likely formed by fracturing caused by excavation of the road cut during road building activities. Excavation showed that the road cut extended below the current level of bar ditch fill.</p>

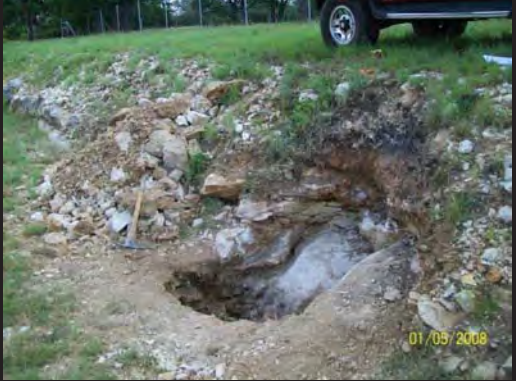
<p>281-017</p>	<p>This feature is situated in the eastern road cut of US 281. It is a solution cavity with two small entrances that are approximately 0.1 m (0.5 ft) in diameter. It drops vertically into the road cut for approximately 0.5 m (1.6 ft).</p>

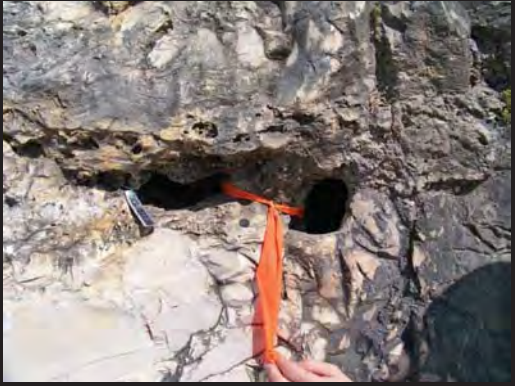
<p>281-018</p>	<p>This is a water utility site. The abundance of manmade features in this developed area is discussed in the body of this report.</p>

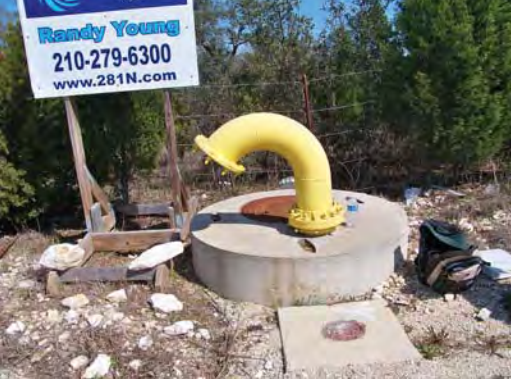
<p>281-019</p>	<p>This feature is a water well near a business.</p>

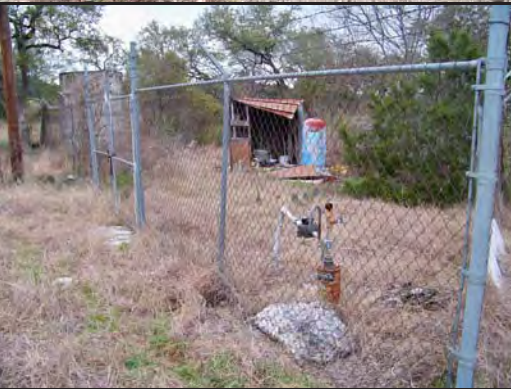
<p>281-020</p>	<p>When initially discovered, this feature was represented by nearly square shaped opening in the ground measuring 0.36 m (1.2 ft) by 0.33 m (1 ft) by 1.75 m (5.7 ft) deep. Photos of the interior of the feature revealed that is an abandoned hand-dug well or cistern.</p>

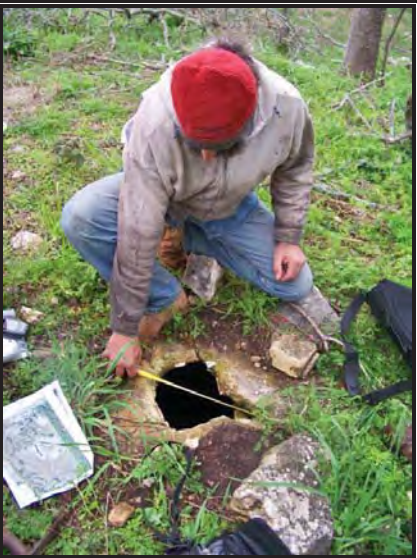
<p>281-021</p>	<p>This solutional sinkhole measures 0.5 m (1.6 ft) by 0.4 m (1.3 ft) across and was 0.8 m (2.6 ft) deep. It was infilled with coarse rocks and organic sediment.</p>

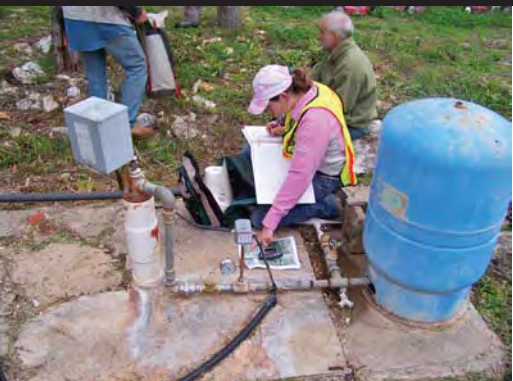
<p>281-023</p>	<p>This feature is a water well behind a business.</p>

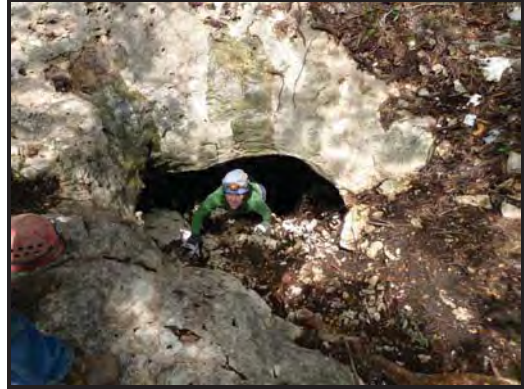
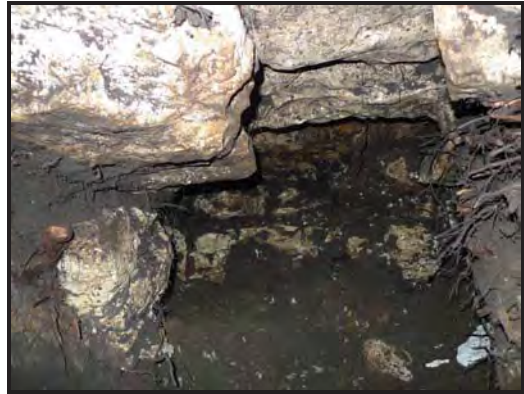
<p>281-026</p>	<p>This solutional sinkhole was initially 1.3 m (4.3 ft) long and 1.2 m (3.9 ft) wide. It was 0.6 m (2 ft) deep and contained leaf litter and clean-washed rocks. The feature is formed along a fracture trending at 45 degrees. Excavation for further evaluation was conducted with hand tools on 19 August, and with a jackhammer on 10 September 2010. A total of 5 person hours of effort was expended, resulting in the removal of 1.3 m³ (46 ft³) of material. A bedrock floor was reached at a depth of 0.5 m (1.6 ft). Lateral excavation along a bedding plane for 0.5 m (1.6 ft) revealed nothing but hard-packed clay. Post-excavation dimensions of the feature were 1.3 m (4.3 ft) long and 1.25 m (4.1 ft) wide and 0.6 m (2 ft) deep.</p>

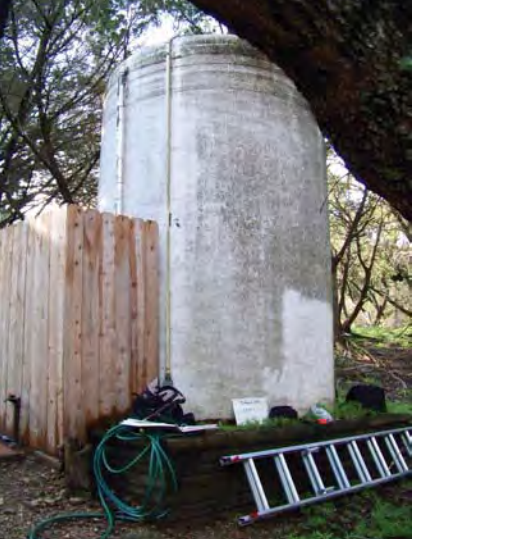
<p>281-028</p>	<p>This feature is a water well.</p>

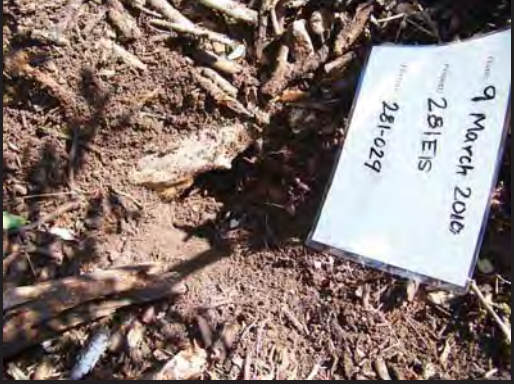
<p>281-030</p>	<p>This depression of undetermined origin contains old stumps, concrete, and rocks. When discovered, it measured 0.5 by 0.25 m (1.6 by 0.8 ft), and was 0.2 m (0.7 ft) deep. Excavation was conducted on 2 August 2010 in order to determine if it was karstic, and 1 m³ (35 ft³) of material was removed utilizing hand tools. This material consisted of chunks of concrete and juniper stumps. The feature was excavated to a depth of 0.75 m (2.5 ft), about 0.2 m (0.7 ft) past the black soil layer into red and white clay. No drains were found. Post-excavation dimensions of this feature were 1.25 m (4.1 ft) in diameter and 0.75 m (2.5 ft) deep. Due to previous anthropogenic activity on the feature, the origin is unclear.</p>

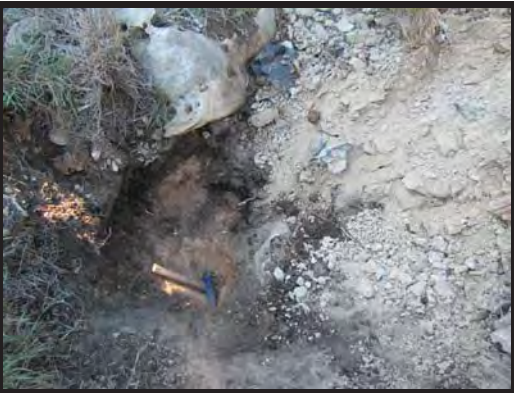
<p>281-031</p>	<p>This sinkhole is composed of a pair of depressions that lies within an area 3.5 m (11.5 ft) in length by 1 m (3.3 ft) wide. They had coarse infill and organic sediment and may be the result of tree removal. It was recommended for excavation in order to determine if it was karstic. Excavation took place on 2 August 2010, and resulted in the removal of 0.4 m³ (14 ft³) of soil from the two depressions. They were dug to depths of 0.3 and 0.4 m (1 and 1.3 ft) to hard packed bottoms with no drains. Post-excavation dimensions of the features were 1 m (3.3 ft) by 0.5 m (1.6 ft) by 0.4 m (1.3 ft) and 0.5 m (1.6 ft) in diameter by 0.3 m (1 ft) deep.</p>

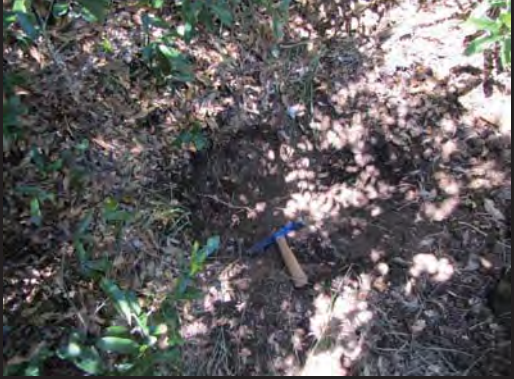
<p>281-032</p>	<p>This sinkhole is 1 m (3.3 ft) long and 0.8 m (2.6 m) wide. It receives recharge from an area measuring 3 by 5 m (9.8 by 16.4 ft). It contained infill of leaf litter and clean-washed rocks. An opossum was observed in this feature. Excavation was conducted on 2 August 2010 for a full evaluation. Black soil and rocks were removed from the floor, reaching a hard-packed bottom with no drains at a depth of 0.9 m (2.9 ft). Post-excavation dimensions of the feature were 1 m (3.3 ft) in diameter and 0.9 m (2.9 ft) deep.</p>

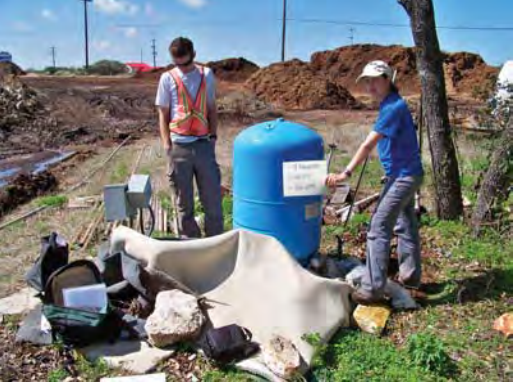
281-034	This feature is a well.

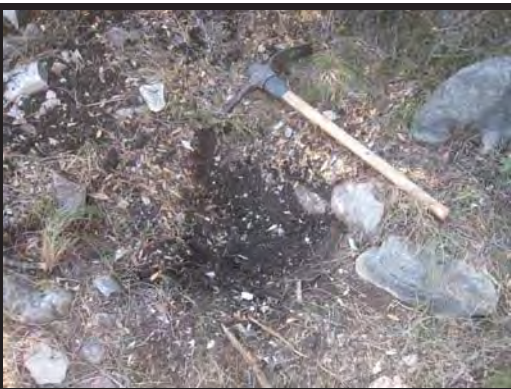
281-036	<p>This non-karst closed depression is located on private property at the northwest corner of Overlook Parkway and US 281. When initially examined, it had a diameter of 1.2 m (3.9 ft) and a depth of 0.5 m (1.6 ft). It was recommended for excavation for a better assessment, which took place on 19 August 2010. This excavation utilized 1.4 person-hours of effort, and resulted in the removal of 0.1 m³ of material. A bedrock floor was reached with no mesocavernous voids extending from the feature. Post-excavation dimensions of the feature were 1.5 m (4.9 ft) in diameter and 0.75 m (2.5 ft) deep. This feature is likely the result of tree-clearing, not karst processes.</p>

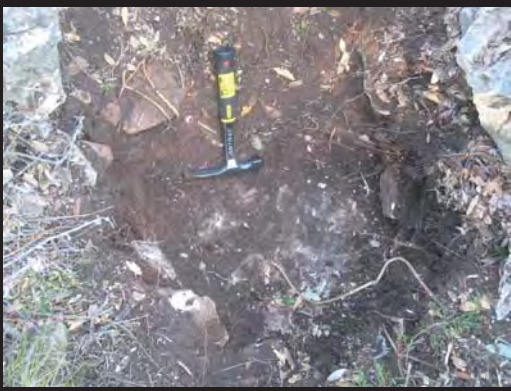
281-037

(Painful Crawl) This cave is formed in an enlarged bedding plane in a road cut associated with a parking lot outside of the ROW. It was partially filled with concrete, but a low passage could be seen extending into the road cut. Excavation was conducted on 15-16 September 2010 to make a full assessment. This resulted in 2 m³ (106 ft³) of rocks being removed from the cave using 20 person hours of effort with hand and power tools. This cave is developed in a low, wide bedding plane, and is just tall enough for human entry. The bedrock and flowstone floor is rough, giving rise to the name Painful Crawl. Excavation concentrated on removing bits of rock from the floor and ceiling in order to be able to enter the passage, but did not change the existing footprint of the cave. Excavation continued 10 m (32.8 ft) until dark zone habitat was reached. The entrance to Painful Crawl is at the bottom of a sloping road cut that is 3.5 m tall. It is 1.4 m (4.6 ft) wide and 0.4 m (1.3 ft) tall. After 3 m (9.8 ft), the passage takes a turn to the east, with small bedding plane openings also extending off to the south and west at this turn. After another 4 m (13 ft), a junction is reached. A dig lead to the north appears that it would connect back to the road cut if excavated. A dig lead also extends to the east. The main passage continues to the south for 3 m (9.8 ft) before it gets too low for human entry. Post-excavation dimensions of the cave were 10 m (32.8 ft) long by 5m (16.4 ft) wide by 0.7 m (2.3 ft) deep.

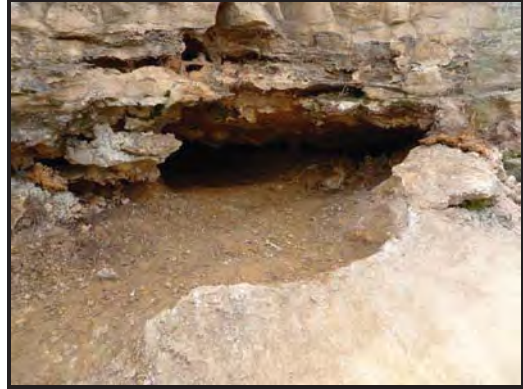
281-038	<p>This solutional sinkhole is 2.3 m (7.5 ft) long, 1 m (3.3 ft) wide, and 0.4 m (1.3 ft) deep. It consists of two holes draining under a bedrock shelf, with infill of leaf litter and organic sediment that is loose to a depth of 0.2 m (0.7 ft). Excavation was recommended to make a full assessment, but right of entry for excavation purposes was not granted.</p>

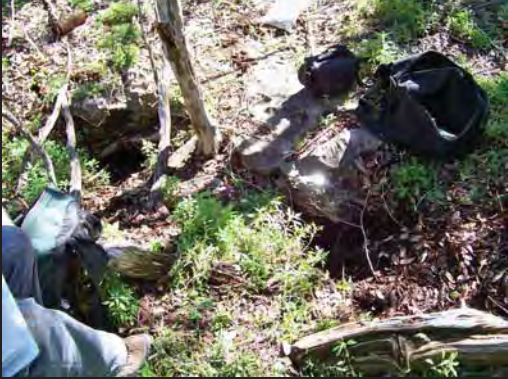
281-039	<p>This non-karst closed depression is located on private property on the west side of US 281. When initially located it was a depression 0.25 m (0.8 ft) in diameter and 0.13 m (0.4 ft) deep, with coarse and fine infill of rocks and organic sediment. Excavation was conducted on 10 September 2010 to make a full assessment. This utilized 0.6 person-hours of effort and removed 0.1 m³ (3.5 ft³) of material. Post excavation dimensions of this feature were 1.5 m (4.9 ft) long by 0.75 m (2.5 ft) wide by 0.5 m (1.6 ft) deep. This feature is located in a landfill deposit, and is a result of poor consolidation.</p>

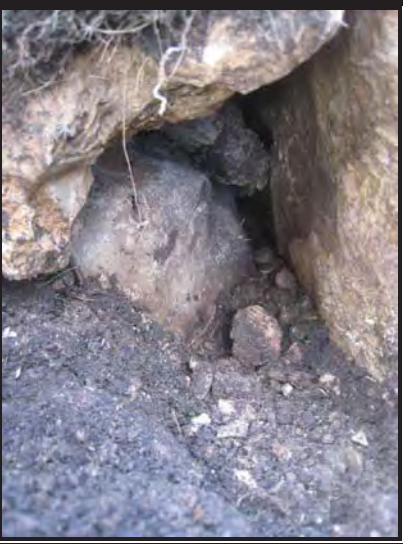
281-040	<p>This non-karst closed depression is located on private property on the west side of US 281. When initially located, it was 1.3 m (4.3 ft) in diameter and 0.3 m (1 ft) deep. It had infill of leaf litter and organic sediment. Excavation was conducted on 10 September 2010, utilizing 1 person-hour of effort and removing 0.2 m³ (7 ft³) of rocks and soil to a bedrock floor. Post-excavation dimensions of this feature were 1.4 m (4.6 ft) in diameter and 0.6 m (2 ft) deep. This feature is erosional in origin, likely the result of bedding plane slumping on a hillside slope.</p>

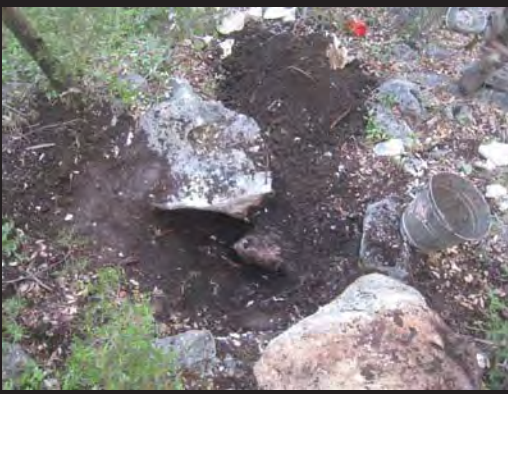
<p>281-041</p>	<p>This solutionally-enlarged fracture is located on private property on the west side of US 281. Prior to excavation, it measured 0.8 m (2.6 ft) in length by 0.1 m (0.3 ft) in width, and was 0.3 m deep. It contained fine, black organic sediment of modern origin. Evaluation via excavation was conducted with a jackhammer on 10 September 2010 utilizing 2 person-hours of effort and removing 0.3 m³ (10.6 ft³) of material. The excavation reached a bedrock floor at a depth of 0.6 m (2 ft), with no mesocavernous voids extending off of it. Post-excavation dimensions of the feature were 1.25 m (4.1 ft) long by 0.75 m (2.5 ft) wide by 0.6 m (2 ft) deep.</p>

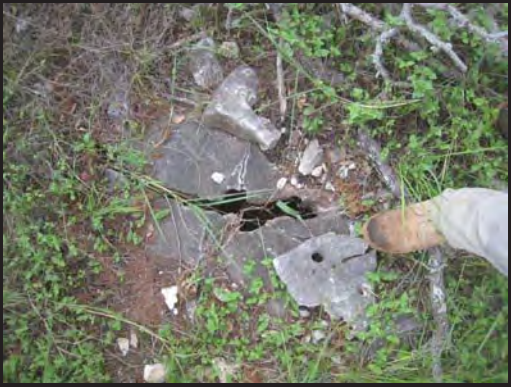
<p>281-042</p>	<p>This non-karst closed depression is located on private property on the west side of US 281. When initially assessed, it consisted of two depressions within an area measuring 1 by 2 m (3.3 by 6.6 ft). It had infill of leaf litter and organic sediment that was loose to a depth of 15 cm (0.5 ft). Excavation was conducted on 10 September 2010. This effort utilized 1 person-hour of effort and removed 0.1 m³ (3.5 ft³) of material. Post-excavation dimensions of the largest feature were 0.75 m (2.5 ft) in diameter and 0.3 m (1 ft) deep. This feature is an old, filled animal burrow that goes under a slab of limestone and exits the other side.</p>

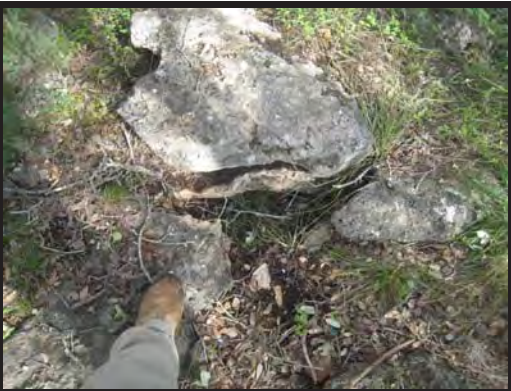
<p>281-043</p>	<p>This non-karst closed depression was 2 m (6.6 ft) in diameter and 1 m (3.3 ft) deep when initially assessed. It had fine infill of leaf litter and organic sediment. Excavation was conducted on 3 August 2010; 1 m³ (35 ft³) of dirt and leaves was removed from the feature. Post-excavation dimensions of the feature were 2 m (6.6 ft) long by 2.5 m (8.2 ft) wide by 1 m (3.3 ft) deep. The floor was hard-packed red clay, with an animal burrow at the south end of the feature. Construction activities on this site later resulted in the area being graded over.</p>

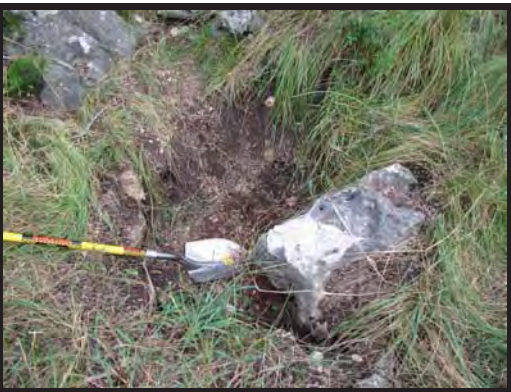
<p>281-044</p>	<p>When initially assessed, this solutional sinkhole was 2.5 m (8.2 ft) long, 1.25 m (4.1 ft) wide, and 1.2 m (3.9 ft) deep. It contained infill composed of leaf litter and organic sediment that was loose to a depth of 20 cm. It is recharged by sheet-wash from an area measuring 30 by 30 m (98 by 98 ft). Excavation in order to further evaluate the feature on 3 August 2010 removed 2.5 m³ (88 ft³) of loose soil and rocks, deepening the feature to 1.8 m (5.9 ft). Post-excavation dimensions of this feature were 2.5 m (8.2 ft) long, 1.25 m (4.1 ft) wide, and 1.8 m (5.9 ft) deep. At that point right of entry for excavation was revoked, preventing further excavation that would likely have led to a cave. The feature was backfilled.</p>

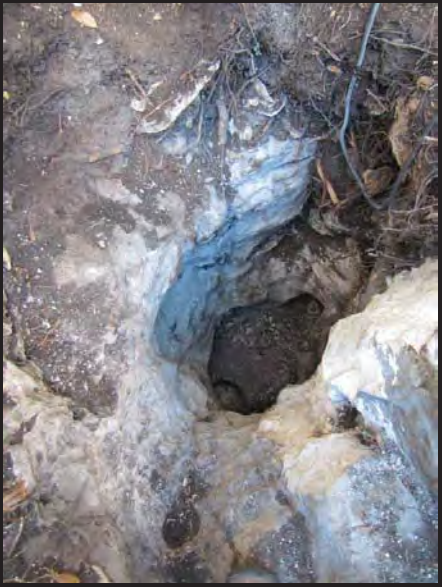
<p>281-045</p>	<p>This cave is located in a drainage, and consists of two low enlarged bedding planes that cut back under the drainage. Flood waters cascading down over the top of these entrances has caused scour, piling up gravel and rocks just downstream. The westernmost of the two entrances extends in for 3 m (9.8 ft) to a bedrock terminus. The eastern entrance extends 4 m (13.1 ft) and also terminates in bedrock. Excavation was conducted on 4, 19, and 25 August to enlarge these bedding plane openings for biological evaluation. Using hand and power tools, 2 m³ (71 ft³) of material was removed with 25.5 person hours of effort. The cave was mapped during a subsequent visit. Post-excavation dimensions of this feature were 7 m (23 ft) long, 4 m (13.1 ft) wide and 0.7 m (2.3 ft) deep.</p>

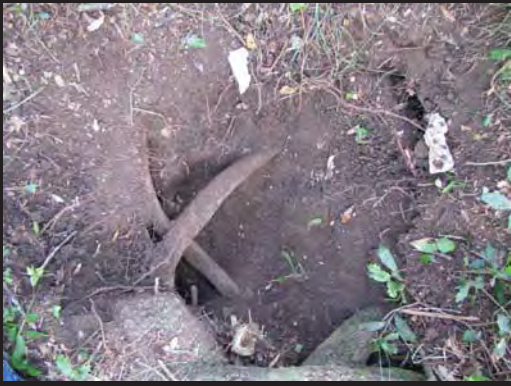
281-047	When initially assessed, this sinkhole was 1.5 m (4.9 ft) long, 1 m (3.3 ft) wide, and 0.4 m (1.3 ft) deep. It contained fine black sediment of modern soil and leaf litter. It was excavated on 3 August 2010 to a solid bedrock floor.

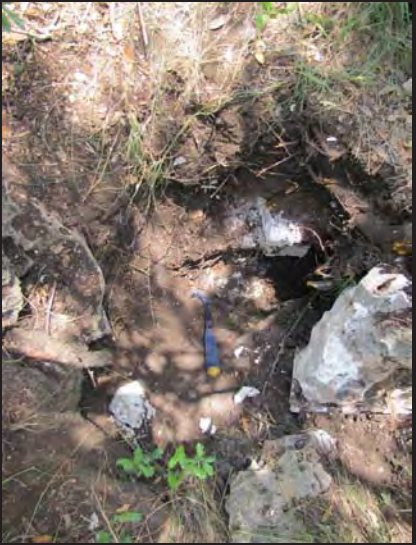
281-048	This solutional sinkhole is 3 m (9.8 ft) long and 1 m (3.3 ft) wide and contained fine infill of black, modern soil and leaf litter. Airflow was detected in the feature on 12 March 2010. It was recommended for evaluation via excavation, but right of entry for excavation purposes was denied.

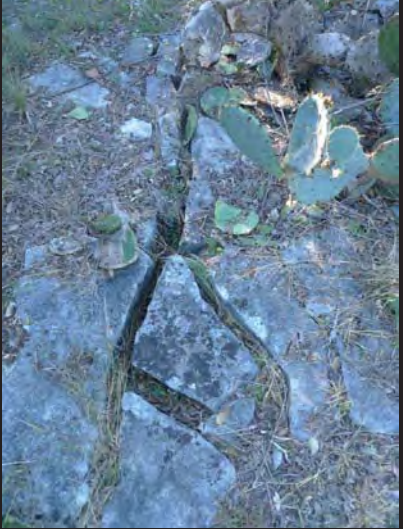
<p>281-052</p>	<p>This non-karst closed depression is located on the west side of US 281 on private property. It is a 10 m-diameter (32.8 ft) depression with a depth of 1.5 m (4.9 ft) formed by the introduction of landfill material on its north side and not by karst processes.</p>

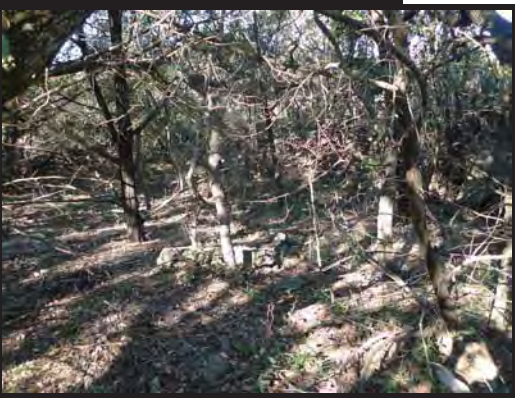
<p>281-053</p>	<p>This non-karst closed depression is located on the west side of US 281 on private property. It is composed of three openings within an area that is 3 m (9.8 ft) long, 0.6 m (2 ft) wide, and 1 m (3.3 ft) deep. This feature is located in the same landfill deposit as feature 281-052. It was recommended for excavation, but when excavation commenced on 10 September 2010, it was immediately determined to be non-karstic. It is formed in a landfill deposit, and is a result of collapse or piping into loose fill.</p>

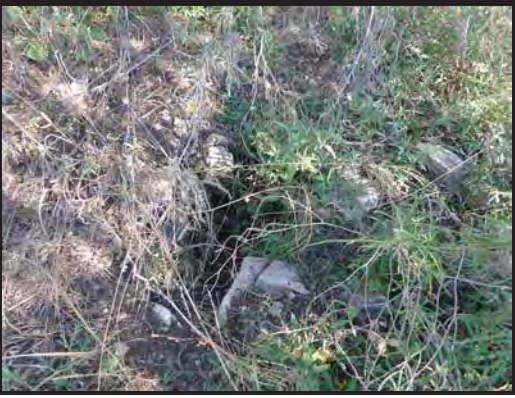
281-054	<p>This solution cavity is at the base of a road cut on private property on the east side of US 281. This opening is 8 m (26.2 ft) wide, 0.3 m (1 ft) tall, and extends at least 0.6 m (2 ft) into the cut.</p>

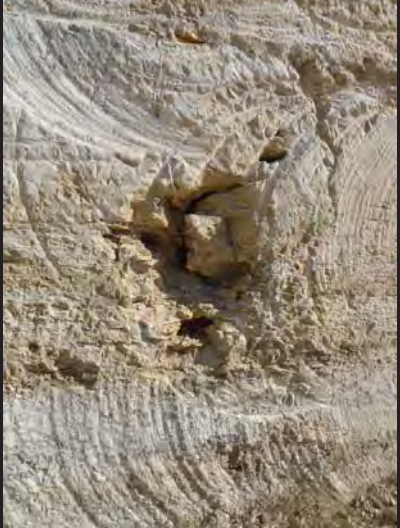
281-055	<p>This solution cavity is an enlarged bedding plane at the base of a construction site road cut on private property. It is 2 m (6.6 ft) wide, 1.7 m (5.6 ft) tall, and extends into the road cut for 1 m (3.3 ft). It is developed along a fracture bearing 90 degrees.</p>

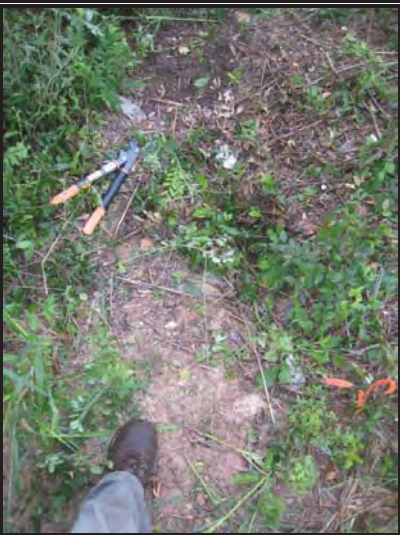
<p>281-057</p>	<p>This sinkhole consists of a depression that is 1.5 m (4.9 ft) in diameter and 0.4 m (1.3 ft) deep. It has a large rock on its south side, and is filled with fine-grained organic sediment and leaf litter that is loose to a depth of 0.3 m (1 ft). There is a small tree with some exposed roots growing from the feature. The feature receives sheetwash flow from an area measuring 25 by 30 m (82 by 98 ft). It was recommended for excavation to make a full evaluation, however right of entry was rescinded prior to the initiation of excavation activities.</p>

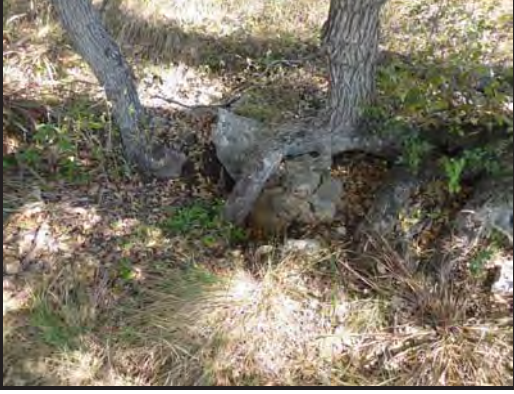
<p>281-058</p>	<p>This potential sinkhole is a depression that is 3.5 m (11.5 ft) in diameter and 0.7 m (2.3 ft) deep. It is filled with soil and has two live oak trees growing out of it. It was recommended for excavation in order to determine its origin; however, right of entry was rescinded prior to the initiation of excavation activities.</p>

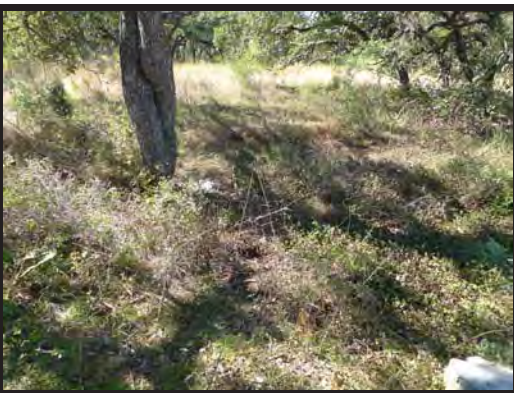
<p>281-059</p>	<p>This non-karst closed depression is 5 m (16.4 ft) long, 3 m (9.8 ft) wide, 0.5 m (1.6 ft) deep, and is surrounded by a curbed parking lot. There are two oak trees within it. It was most likely formed by the area surrounding it being built up for the parking lot, with the area around the trees left unfilled so that the trees would not die.</p>

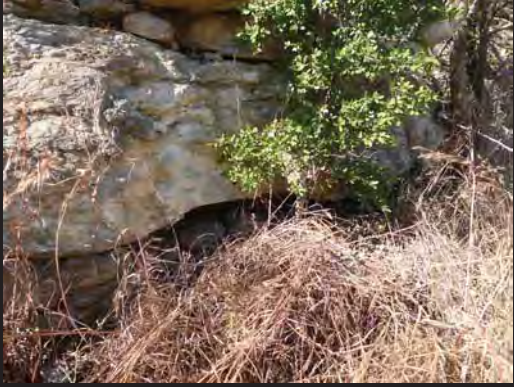
281-061	<p>This feature is an enlarged fracture developed along a trend of 90 degrees in a road cut on the west side of US 281. It is 0.4 m (1.3 ft) wide, 0.9 m (2.9 ft) tall, and extends into the road cut for 1.25 m (4.1 ft).</p>	<p>No photograph available.</p>

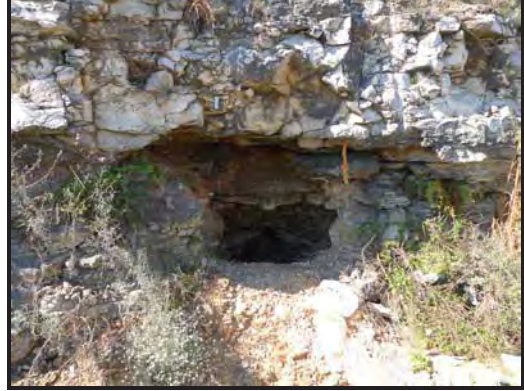
281-062

When this cave in the road cut on the west side of US 281 was first discovered, it had a 1.9 m wide and 0.75 m high entrance, and extended 2 m (6.6 ft) into the road cut. Excavation was conducted on 3 June 2010 for a full evaluation, and 3 m³ of material was removed. These rocks were lightly cemented together with calcite, with voids between them. The excavation trended back underneath the roadway with an unstable ceiling, and excavation efforts ceased about 5 m into the feature. Post-excavation dimensions of the cave were 5.4 m long (17.7 ft) by 1.5 m (4.9 ft) wide and 3.4 m (11.1 ft) deep.

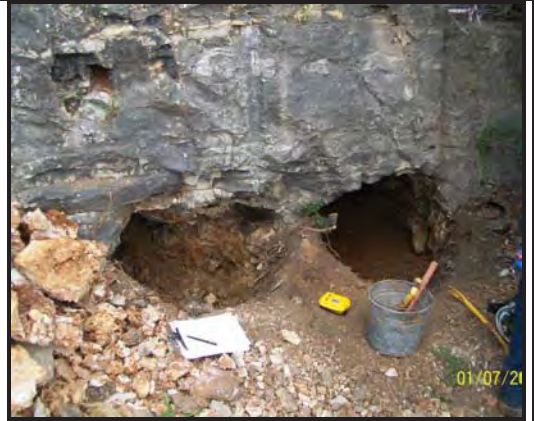
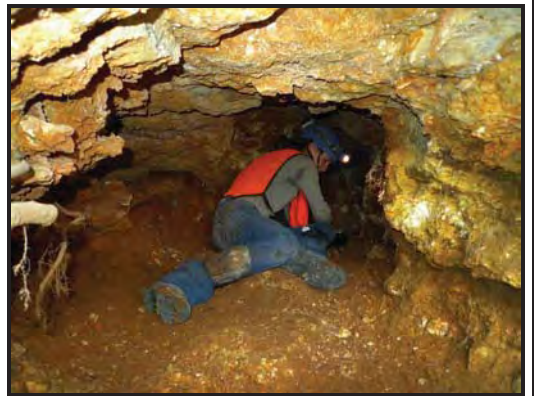
281-063

This cave is in the road cut on the west side of US 281, south of Encino Rio. It has two entrances at the base of the road cut that were initially 0.5 m (1.6 ft) wide. The northern entrance could be seen to extend 2 m into the road cut and continued on. It contained infill of leaf litter and organic sediment. It was excavated on 3, 14, and 23 June 2010. These excavations resulted in the removal of 3 m³ of material from the feature. The resulting cave is 7 m (23 ft) long, with a small connection between the two entrances that is not humanly passable. Each entrance is 1 m (3.3 ft) wide and both passages drop below the level of the roadway shoulder to a depth of 1.4 m (4.6 ft). The south entrance quickly rejoins the main passage in the north section. The cave ends in a flowstone wall.

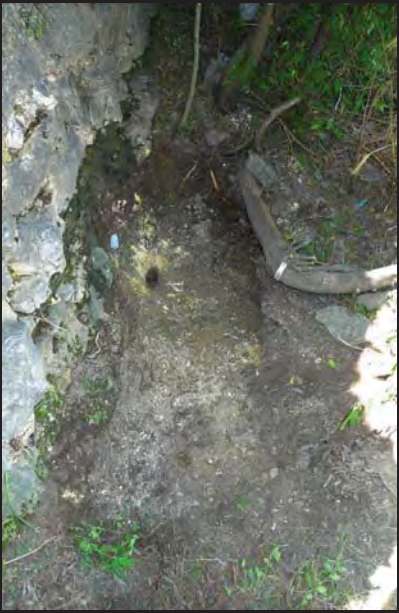
281-065	<p>This is a solutionally enlarged fracture in the road cut on the west side of US 281 that had an opening 0.5 m (1.6 ft) wide and 1 m (3.3 ft) high. It dropped downward at least 0.5 m (1.6 ft). It was excavated on 17, 21, and 23 June 2010 for 17 person hours, removing 1.25 m³ (44 ft³) of hard rock with jackhammers. After excavating to a depth of 1 m (3.3 ft), no voids could be seen extending from the feature. Post-excavation dimensions of the feature were 1 m (3.3 ft) in length by 1 m (3.3 ft) in width by 1 m (3.3 ft) in depth.</p>

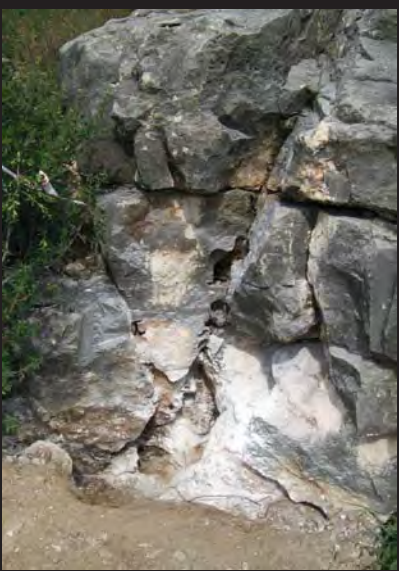
281-066	<p>This solution cavity is located in the road cut on the west side of US 281. It has a trend of 90 degrees that is 0.5 m (1.6 ft) wide, 0.25 m (0.8 ft) tall, and it extends into the road cut for 1.25 m (4.1 ft).</p>

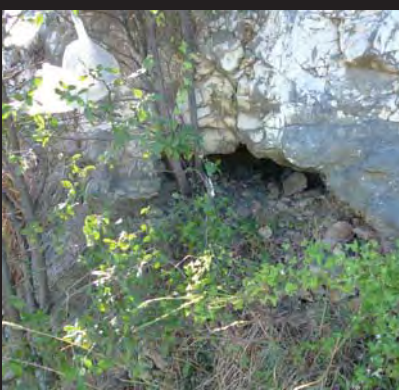
<p>281-067</p>	<p>This feature appears to be a collapse sinkhole. It is 1 m (3.3 ft) in diameter and 0.3 m (1 ft) deep, with infill composed of organic sediment, leaf litter, and rocks. It was recommended for evaluation via excavation, but right of entry for that purpose was denied.</p>

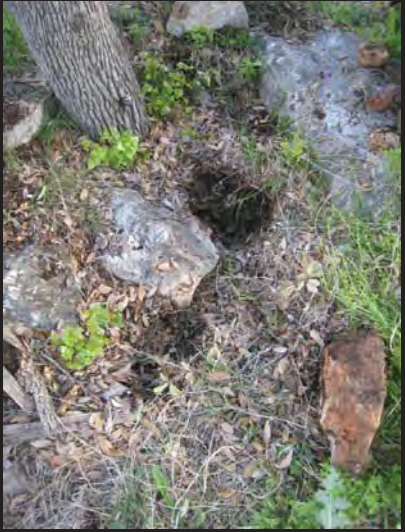
<p>281-068</p>	<p>This feature is a water well.</p>

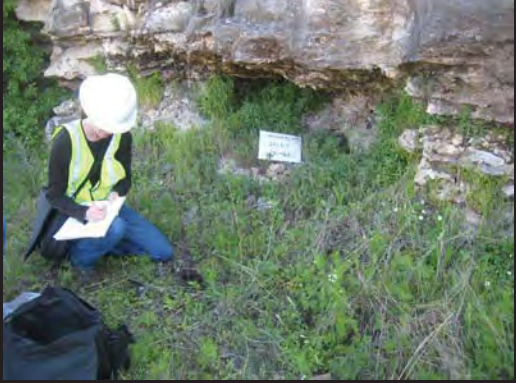
281-070

(Stafford Cave) This cave is located in the east road cut of US 281. It is an enlarged bedding plane that had an entrance 0.4 m (1.3 ft) m in diameter, and it could be seen to extend 1.5 m (4.9 ft) into the road cut with a small opening continuing on. Slight airflow was detected. It was excavated on 16-17 June 2010 for full evaluation. Fourteen person-hours of effort were utilized to remove rocks in order to make the crawlway passable. The cave can be entered for 9 m (29.5 ft) before it becomes too low to pass. The post-excitation width was 2 m (6.6 ft) and the depth was 1 m (3.3 ft). The cave was named for the brand of an article of clothing found in the entrance.

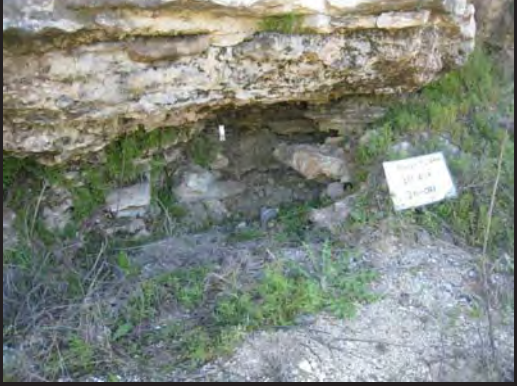
<p>281-071</p>	<p>This solution cavity is located in the east road cut of US 281. It is an enlarged bedding plane with an entrance that is 2 m (6.6 ft) wide and 1 m (3.3 ft) high. It extended for 3 m (9.8 ft) into the road cut, with a small hole continuing on. Previous excavation has occurred here, as evidenced by a tailings pile just outside of the entrance. It was excavated on 16 June 2010 for a full evaluation. About 1m³ (35 ft³) of rock was removed from the back of the feature, which was a bedding plane shelf with small openings continuing on. The post-excavation dimension were 3 m (9.8 ft) long by 2 m (6.6 ft) wide by 1.3 m (4.3 ft) deep. One troglobite (<i>Brackenridgia</i> sp.) was encountered during excavation.</p>

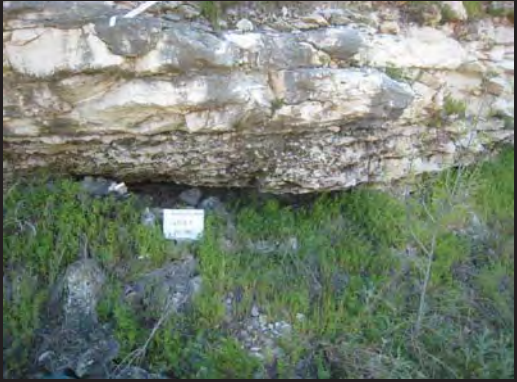
<p>281-072</p>	<p>This solution cavity is an enlarged bedding plane opening that is 2.5 m (8.2 ft) wide, 0.4 m (1.3 ft) tall, and extends 1.5 m (4.9 ft) into the road cut. Tiny mesocavernous voids extend off of it in the same bedding plane as surrounding caves and features.</p>

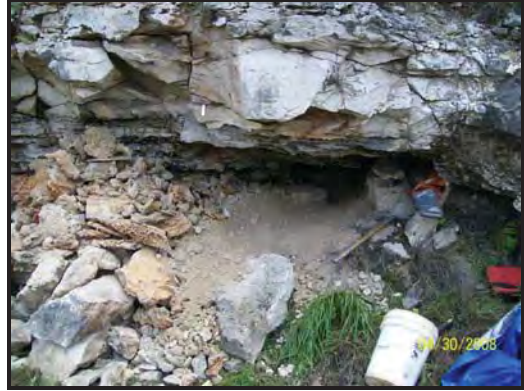
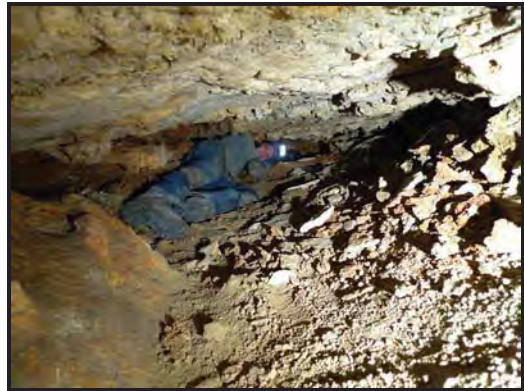
281-073

(Cool Cave) This cave is developed in an enlarged bedding plane in the east road cut of US 281. When initially assessed, its entrance was 2 m (6.6 ft) wide and 0.5 m (1.6 ft) high. It extended at least 3 m (9.8 ft) into the road cut, with mesocavernous voids continuing on. It was excavated on 15-16 June 2010 for a full evaluation. Three m³ (106 ft³) of material was removed utilizing 20 person-hours of labor with hand and power tools. This resulted in enlargement of the entrance to 1m (3.3 ft) in height, and enabled access to the full 10 m (32.8 ft) length of the cave. It was named for the cool temperature inside relative to the outside summer heat. The cave begins as a dirt-floored crawl, and widens out to 3.5 m (11.5 ft) across. At this point there is a shallow pit on the north side of the passage with a damp bedrock floor. The back portion of the cave gets very low. The post-excavation dimensions of this feature were 10 m (32.8 ft) long by 1 m (3.3 ft) wide by 1.2 m (3.9 ft) deep.

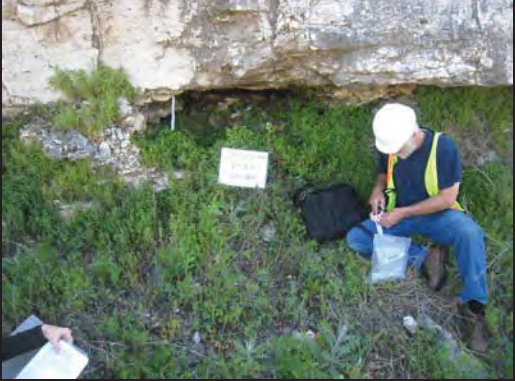
281-074	<p>This solution cavity is an enlarged bedding plane in the road cut on the east side of US 281. It is 1 m (3.3 ft) wide, 0.3 m (1 ft) tall, and extends into the road cut for 1 m (3.3 ft).</p>

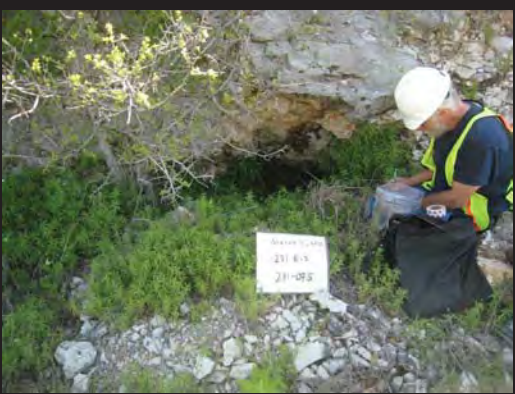
281-076	<p>This solution cavity is an enlarged bedding plane in the east road cut of US 281. The entrance to the feature is 0.5 m (1.6 ft) wide and 0.3 m (1 ft) tall. It extends into the road cut for 1 m (3.3 ft). It contains smooth bedrock walls with no infill material.</p>

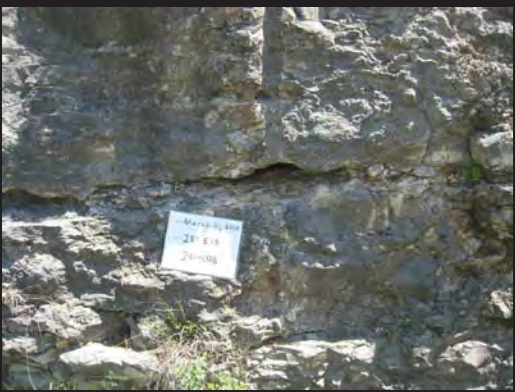
281-077	<p>This solution cavity is an enlarged fracture with a trend of 150 degrees. It is situated in the east road cut of US 281. The entrance is 0.25 m (0.8 ft) wide, 0.25 m (0.8 ft) tall, and it extends into the road cut for 0.4 m (1.3 ft). It contains minor amounts of rock infill, and flowstone covering some surfaces. Gastropod shells were observed in this feature.</p>

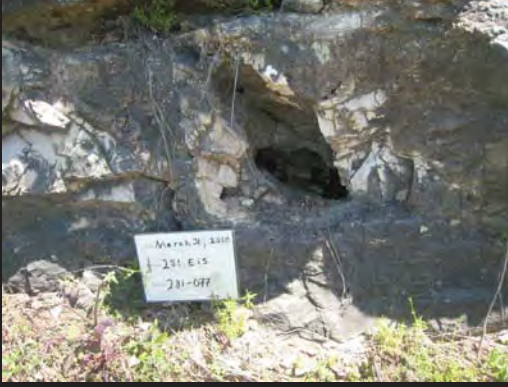
281-078	<p>This solution cavity is located in the east road cut of US 281. It is an enlarged bedding plane with an entrance that is 0.4 m (1.3 ft) wide and 0.2 m (0.7 ft) high. It extends at least 1.5 m (4.9 ft) into the road cut with a continuing void, and has slight airflow. It was excavated on 21 June 2010. Utilizing 6 person-hours of labor, 1 m³ (35 ft³) of material was removed; no continuing voids were seen. Post-excavation dimensions of the feature were 1.5 m (4.9 ft) long by 1 m (3.3 ft) wide by 0.5 m (1.6 ft) deep.</p>

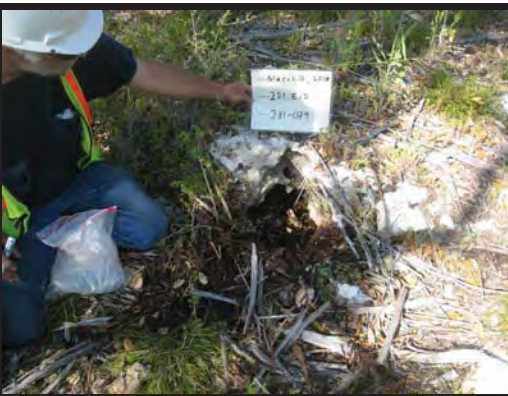
281-079	<p>This feature is located on private property on the east side of US 281. The entrance is 0.4 m (1.3 ft) wide, 0.3 m (1 ft) tall, and it extends in for at least 0.5 m (1.6 ft). It appears to be an epikarstic void that was enlarged by animal burrowing.</p>

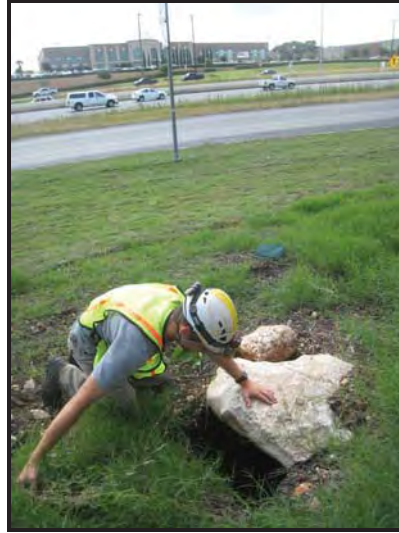
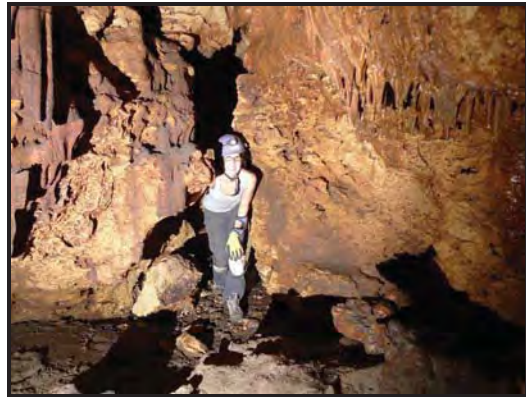
281-080

(Power Pole Hole) This cave is located on the west side of US 281, to the south of Sonterra Boulevard. It is just inside the ROW, about 8 m (26.2 m) from the edge of pavement of the US 281 feeder road. This is a cave that was apparently intersected by power pole drilling installation operations sometime in the past. Although this feature was partially open when initially assessed, excavation was needed to remove fill material that had been dumped in. A large quantity of recycled asphalt had been dumped into the cave in an apparent effort to plug the cave. Excavations were conducted on 20 May, 11, 12, 17, and 29 June, 19, 20, and 26 August, and 10 and 17 September 2010. A total of 8.16 m³ (288 ft³) of material was removed from the feature using 97.8 person-hours of effort. The entrance to Power Pole Hole is 0.8 m (2.6 ft) in diameter and was covered with a limestone slab when initially encountered. When initially assessed, the cave consisted of a 3 m (9.8 ft) climb-down to a plugged floor. The northern crawlway went for 3 m (9.8 ft) to a terminus. The southern crawlway went down the slope past the ground rods, and then sloped upward in a low section that opened up into a spacious chamber. This chamber is about 7 m (23 ft) across and up to 4.5 m (14.8 ft) in height. Flowstone and stalactites cover parts of the ceiling, walls, and floor. Most of the floor consists of silt. Mesocavernous voids extend off of the western portion of the room at different points of the walls and ceiling. Post-excavation dimensions of this feature were 13 m (42.7 ft) long by 5 m (16.4 ft) wide) by 1 m (3.3 ft) deep. This cave receives a considerable amount of moisture from various sources. Drainage is channeled into it by landscaping modifications related to an adjacent hotel. The hotel filtration pond drains into it. Sprinklers installed to water the grass on the ROW also drain to the cave.
